CHAPTER NINE

Special Situations

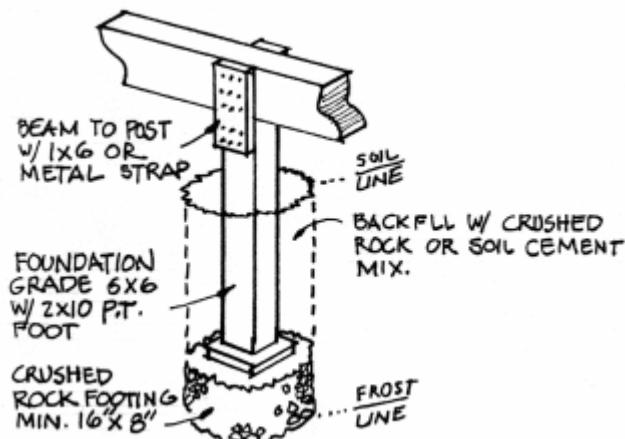
Figure 9-1

This type of construction is found in areas where the soil grade is not level. Posts more than six inches in diameter are set into holes about three feet deep. The length of the posts is selected to suit the grade. Long cleats are attached to both sides of these posts and the structure is supported on these cleats. These are often flat roof residences in recreational areas. The entire structure is made of wood. Anticipate this type of construction in structures originally designed for vacation camps or summer camps then subsequently used for year around residence. Modern home construction or commercial buildings often have posts made of metal.

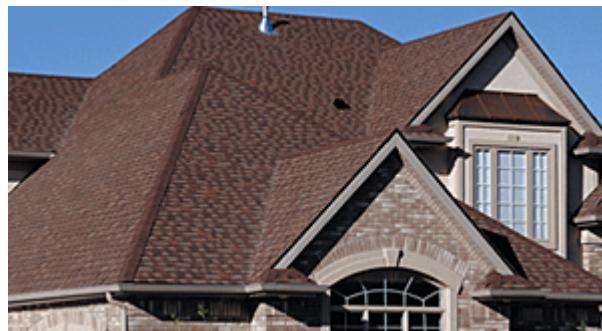
Figure 9-2

Improperly vented attic areas below the roof will accumulate moisture and provide a harborage for carpenter ants and other Wood Destroying Insects (WDIs).

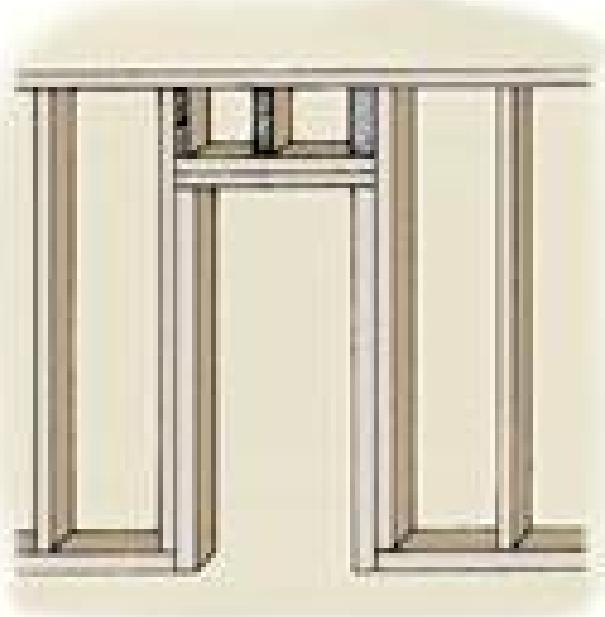
Figure 9-3

Exterior doors can become sources of problems with insects if they are improperly flashed and maintained. Moisture entering around chipped paint, missing caulk, and hardware open to the weather can be a source for WDI activity.

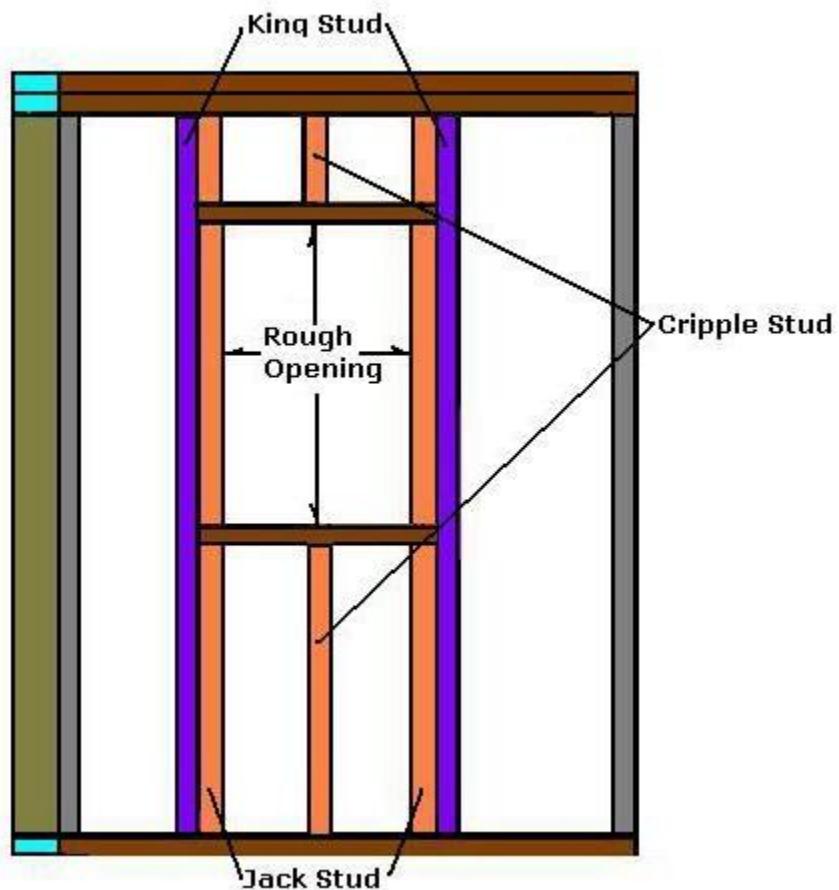
Figure 9-4

The complex nature of construction around a window opening: Framing, flashing, exterior foam insulation systems (EIFS), sliding track, caulk, glass, and mixed construction materials, makes these an excellent area for insect entry if improperly maintained.

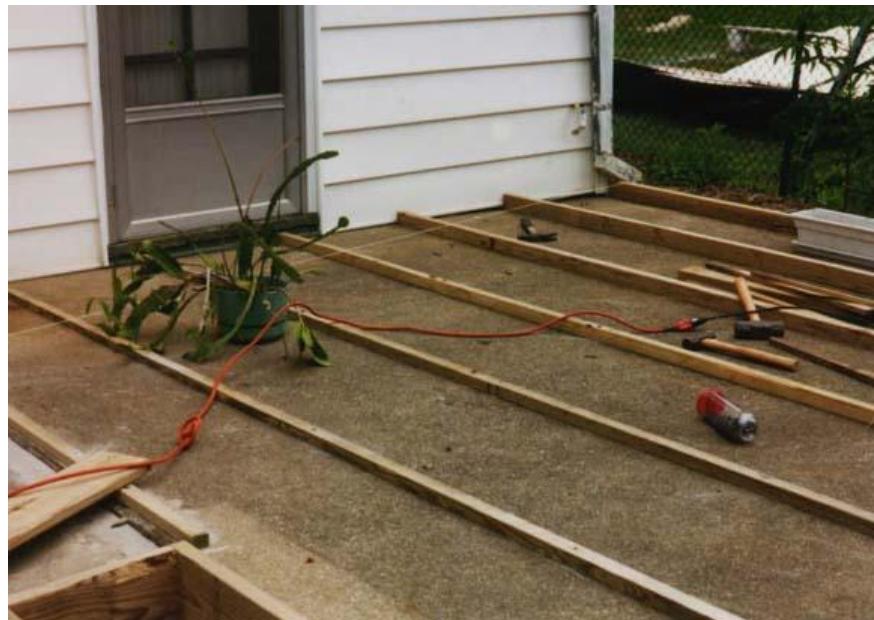
Figure 9-5

The current popularity of wood decks around houses recalls the previous era when houses were built with large veranda porches. In both instances the carpenters often placed wood in contact with soil. The newer decks, which are treated with Chromate Copper Arsenate (CCA), Amine Copper Quat (ACQ), Copper Azone (CA) or other preservatives, are said to be insect proof. Carpenters saw through the treated surface, drive nails, drill bolt holes, etc. thus breaking the toxicant barrier. Moisture and insects can enter easily. Often these decks or porches have no room for access underneath.

In older homes, decks are often seen as an inexpensive means to cover over a concrete patio that has cracked or developed other structural problems. Because they are outdoors, exposed to weather and insect attack, they require the careful concern of a WDI inspector.

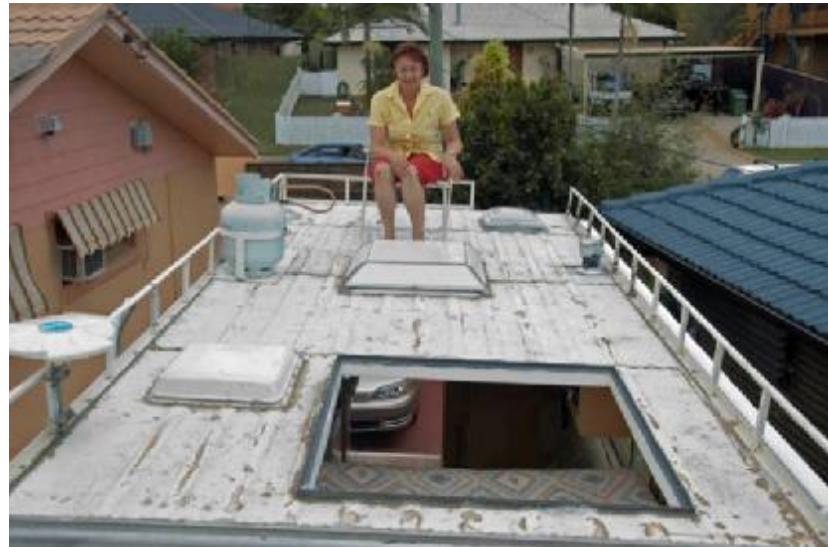
Figure 9-6

Decks on the top of flat-roofed houses are an immediate red flag to a WDI inspector. The use of the roof as a bearing surface for loads it was never intended to hold often breaks the roofing seal. It is possible for moisture and insects to gain access to the joists below. Since these joists are inaccessible, insect activity and/or damage may be undetectable.

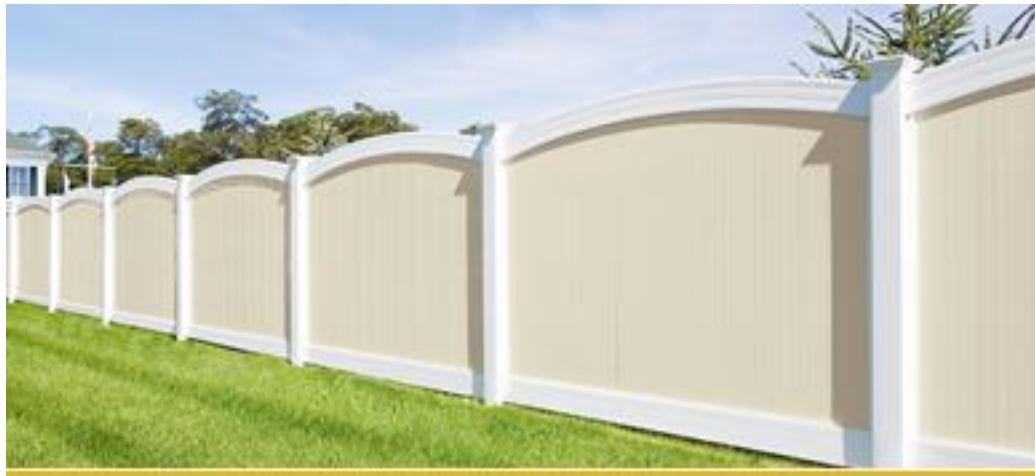
Figure 9-7

Ornamental wood fences abound in suburbia. Wood posts buried in soil, or worse, in concrete, are open invitations for insects to attack. Some wooden posts are pressure-treated, but the actual fencing material is often untreated wood. Digging around the grass growing at the base of the fence posts often discloses evidence of insect attack. Finding wood destroying insects in this area does not signify an infested structure, although if the fence is directly attached to the structure, the implications are obvious. If the inspector believes this problem is important to the buyer, he will report this observation in the comments section of the inspection report (NPMA-33).

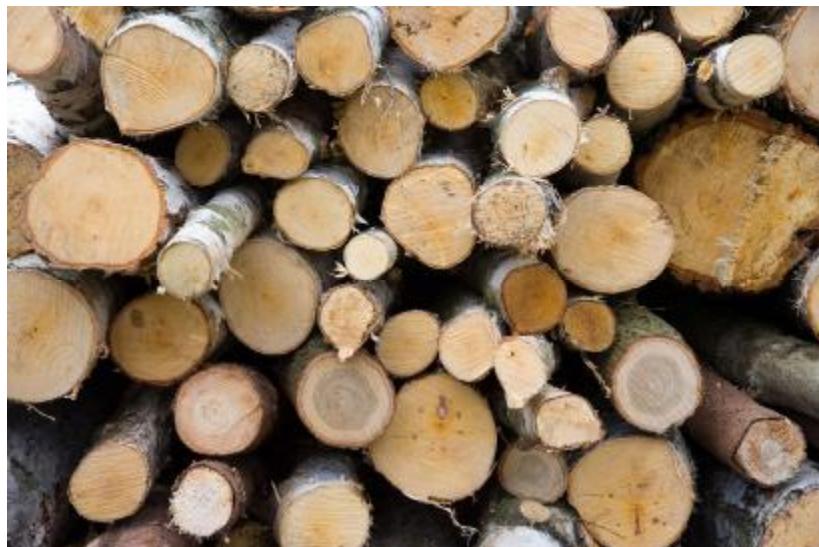
Figure 9-8

Firewood stacked on the ground against or near the structure requires close attention. WDI's often attack these piles. If the piles are infested and the inspector fails to report the infestation, the situation may lead to litigation or at the very least a combative customer. Even if clear of pests, the firewood pile may find a place on the inspection graph. If it is on the ground and too close to the house, our duty to disclose may require such reporting.

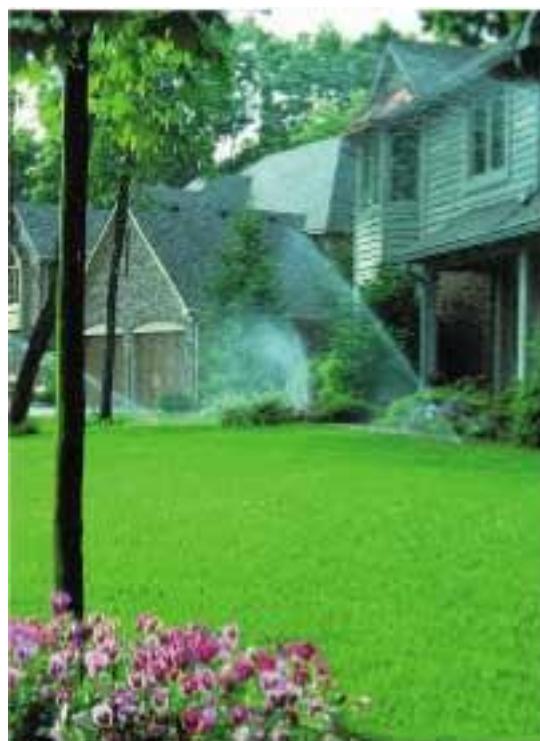
Figure 9-9

Frequently watered areas near the structure foundation will attract the inspector's attention (e.g. a broken down spout, a leaky faucet or a leaky air conditioner). Termiteicide applied to these areas may have been washed away (or leached from the soil) and the protection with it. Any wood nearby should be examined. Wood mulch around a structure creates a condition favorable for termite activity. If the structure was treated years ago, layers of untreated mulch can be a pathway for insects to enter the house. On the sunny side if the structure, the warm wood chip mulch can be a nursery for new termite colonies. On the rainy, wet north side of the house, the continuous moisture can encourage nearby termite colonies to move toward the house. Properly applied termiticides may be ineffective in such situations. Woody plant roots nearby may provide insect harborage. Excessive plant cover limits the inspection, which can be performed. These plants can also limit the amount or drying air movement between the structure and the shrubs. Woody shrubs put out new feeder rootlets each spring. Each fall these soft, tender, young rootlets die., creating an ideal food source for worker termites. Termite swarmers can be blown into the shrubs and use the protected soil under them as a place to start colonies. The winter conditions may never penetrate these eco-niches under these heavy shrubs.

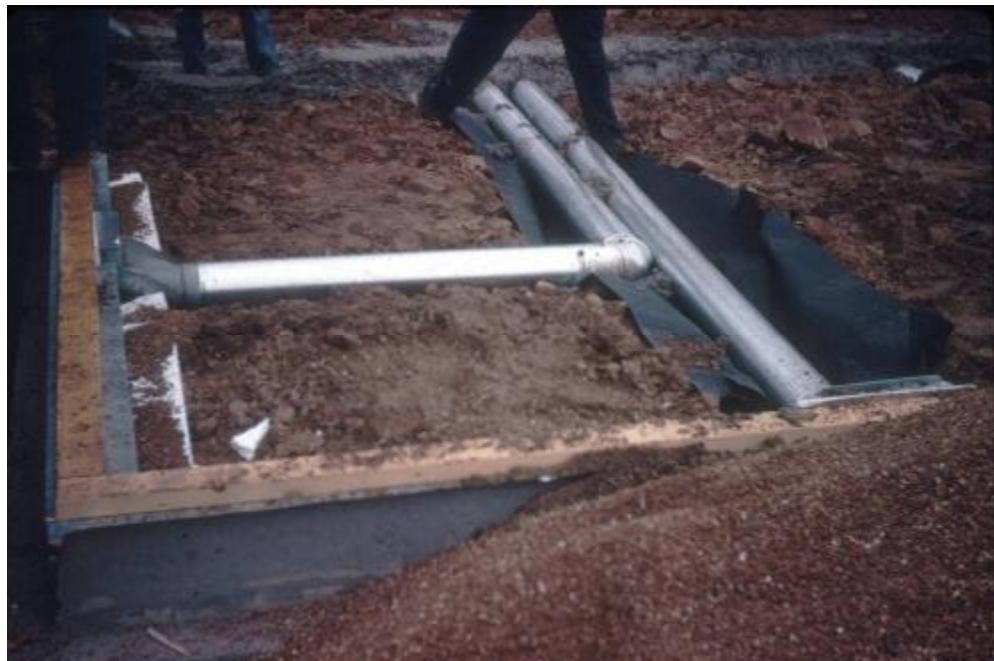
Figure 9-11

Hot air heat ducts within a slab are a potential blessing to wood destroying insects and a potential curse to the homeowner who owns such a heating system. Safe, effective treatment techniques are few, and the chance of infestation is high. The inspector reporting on such structures should take nothing for granted. His report should be as extensive, complete, clear and accurate as possible.

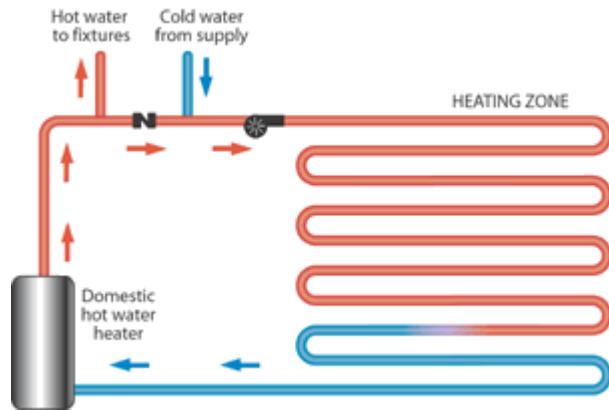
Figure 9-12

Radiant heat cables or pipes in the slab of the structure are almost as much of a problem as the heat ducts mentioned above, only the safety hazard factor is less. Inspection is limited. The constantly warm concrete floor is a termite's delight. Inspections made on these homes should be reported with as much information to the buyer as possible about the termite hazard.

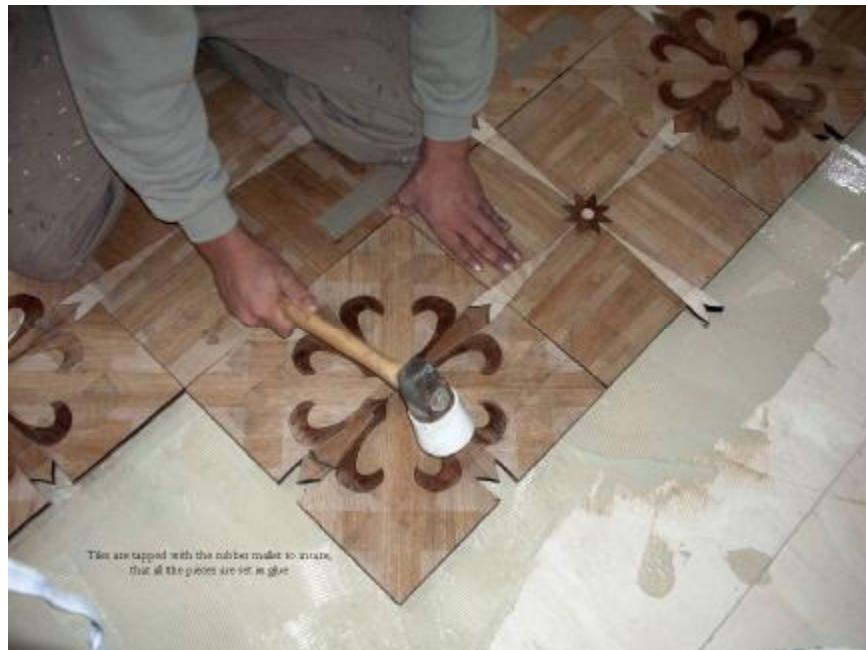
Figure 9-13

Hardwood parquet tiles glued to cement floors are another problem similar to the one just before mentioned. Curing concrete always develops hairline cracks. Slabs in hastily built structures may vary in thickness. Termites may be able to enter through these cracks and attack the parquet tiles. Inspection for this situation is difficult. Carpeting, furniture, and throw rugs can cover these problems easily.

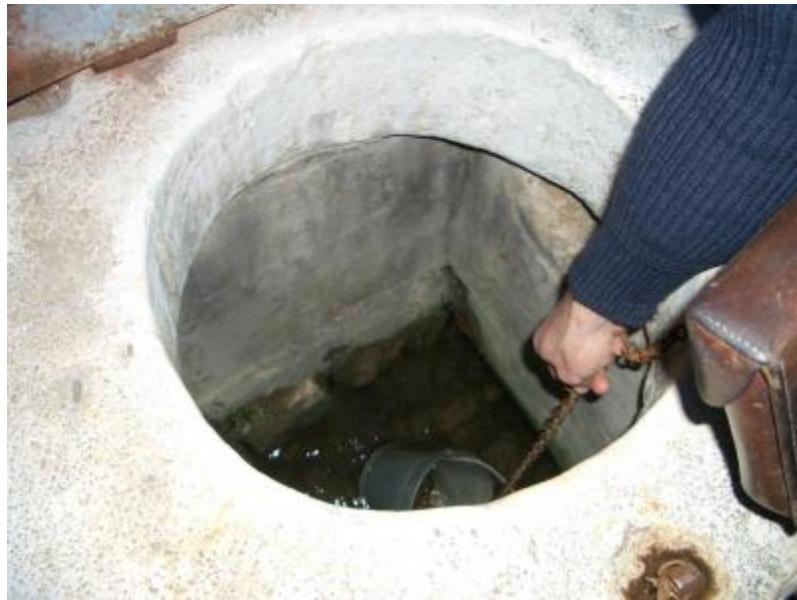
Figure 9-15

A water **well or cistern** within the foundation walls can cause concerns about possible treatment techniques. The existence of these may signal a moisture problem within the structure. The reality of these should be graphed and strong wording included on the report about who would be responsible for any future costs for treatments and preparations for treatment.

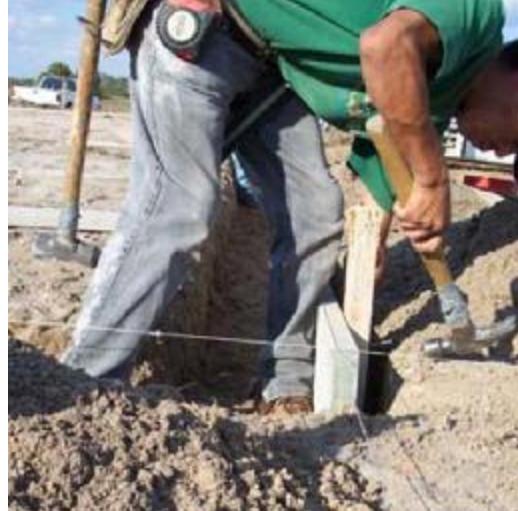
Figure 9-15

Wooden form boards are sometimes left in the holes through concrete slabs where bathtubs, or sink drains, etc. exit the building. Instructions on the NPMA-33 may require opening of these areas for inspection.

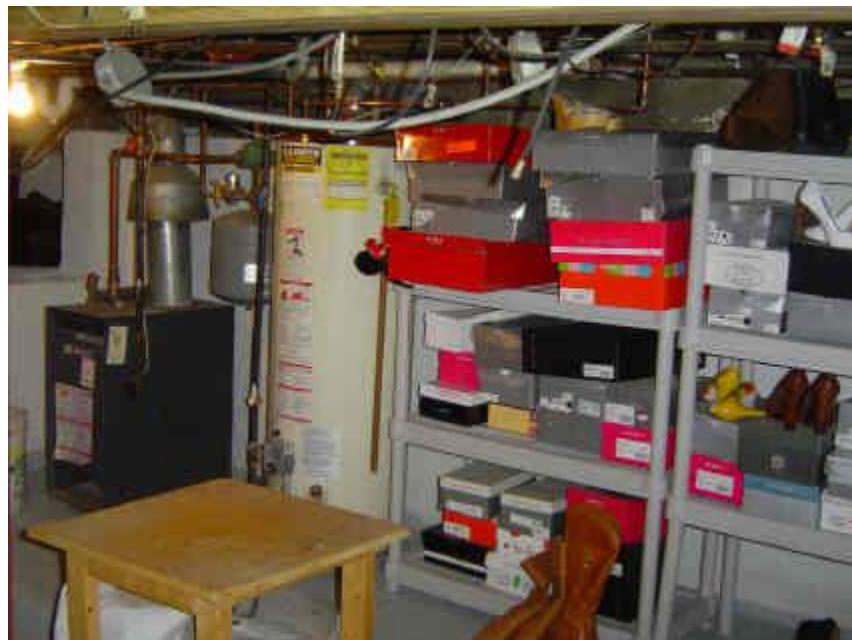
Figure 9-16

Forced hot air **furnaces** near outside walls, and hot air ducts ending near outside walls keep the building and in the adjacent soil in those areas warm year-round. Soil warmed by the heating unit may encourage the development of fungi and insects. Should these warm spots be near a large tree or shrub, a front porch, an attached slab, or any other cover providing insects protection from the weather, the chances of WDI activity is greatly increased.

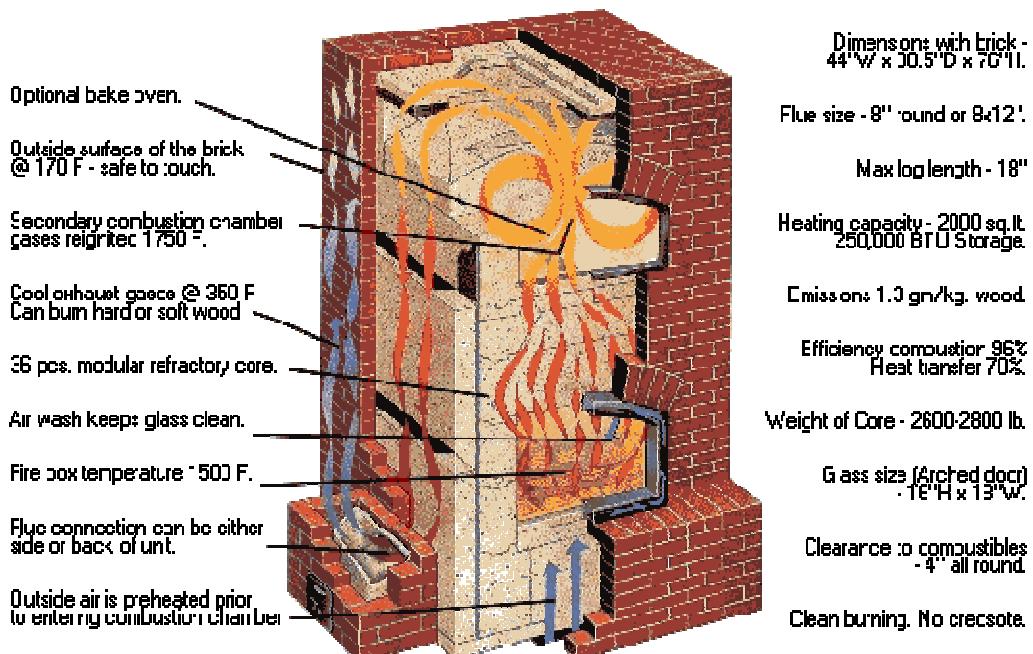
Figure 9-17

Fireplaces, the real ones with foundations, are difficult inspection scenarios. Sometimes the fireplace foundation is inadequate. The fireplace begins to fall away from the house leaving an entrance for rainwater and insects. If the fireplace is used, the bricks are warm during the winter. Sometimes the chimney of the fireplace is shared with the furnace. Exhaust gases from the furnace keep the bricks warm. Newly established termite colonies may take advantage of this warmth.

Temp-Cast Specifications

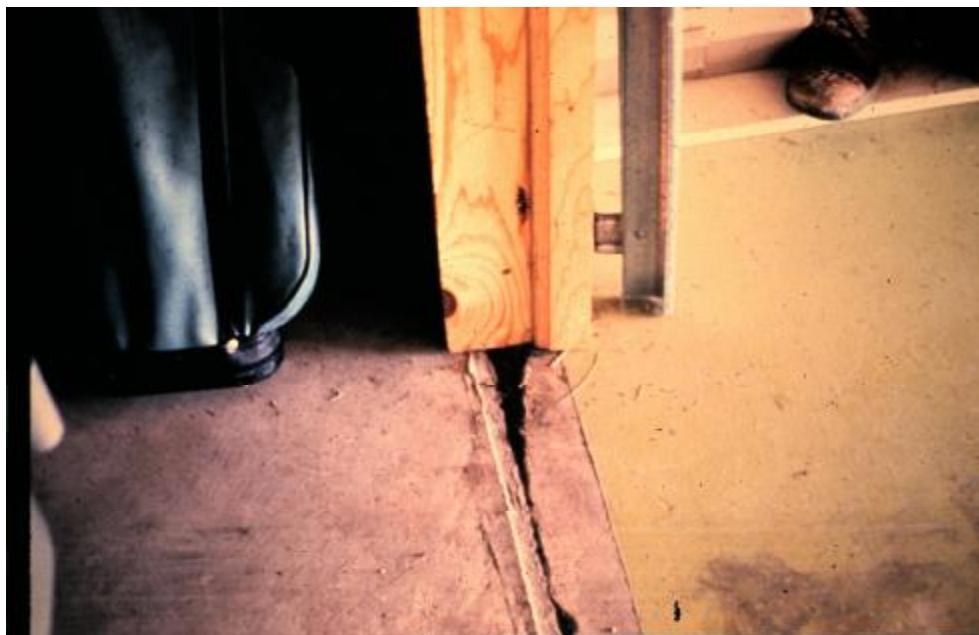
Figure 9-18

Remodeling of structures often results in **double foundations** where additions have been attached. A second foundation is placed alongside the original foundation to support the new addition. These situations allow hidden access for insects, hidden areas for moisture to cause problems, and because they're hidden, problems in treating. Information provided by the property owner is the only way the inspector is aware this situation exists.

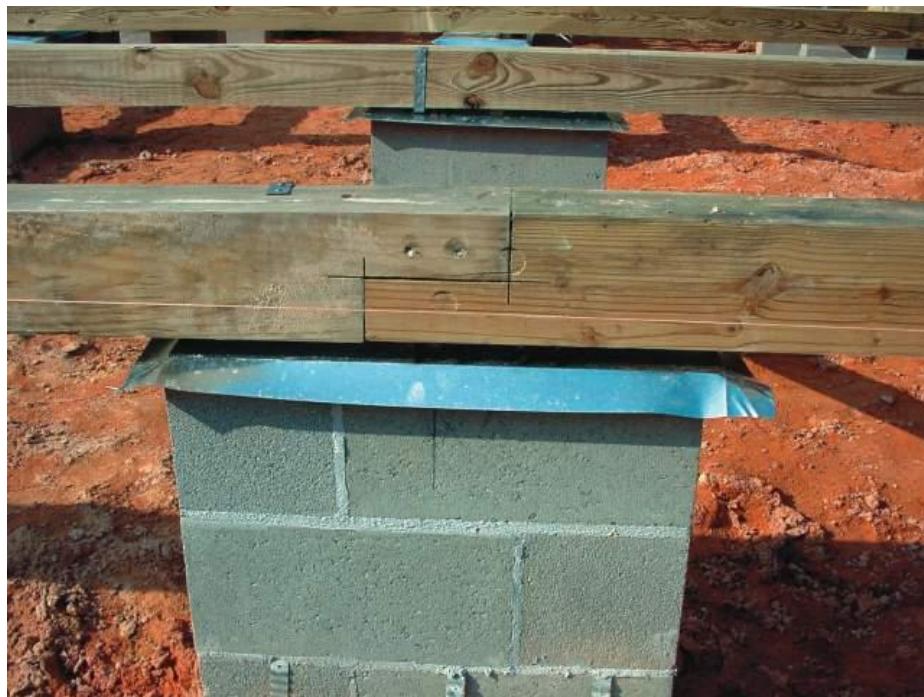
Figure 9-19

Metal "termite shields" have been placed on top of foundation walls as a partial barrier to keep termites from the cellulose of the structure. Shields are best suited to be an adjunct to a routine termite inspection to help see the termites, since the termites will construct their shelter tubes over them. These shields are often installed improperly or are rendered useless by construction. Exterior siding and interior finished walls often are placed so the shield is covered and crushed against the foundation wall.

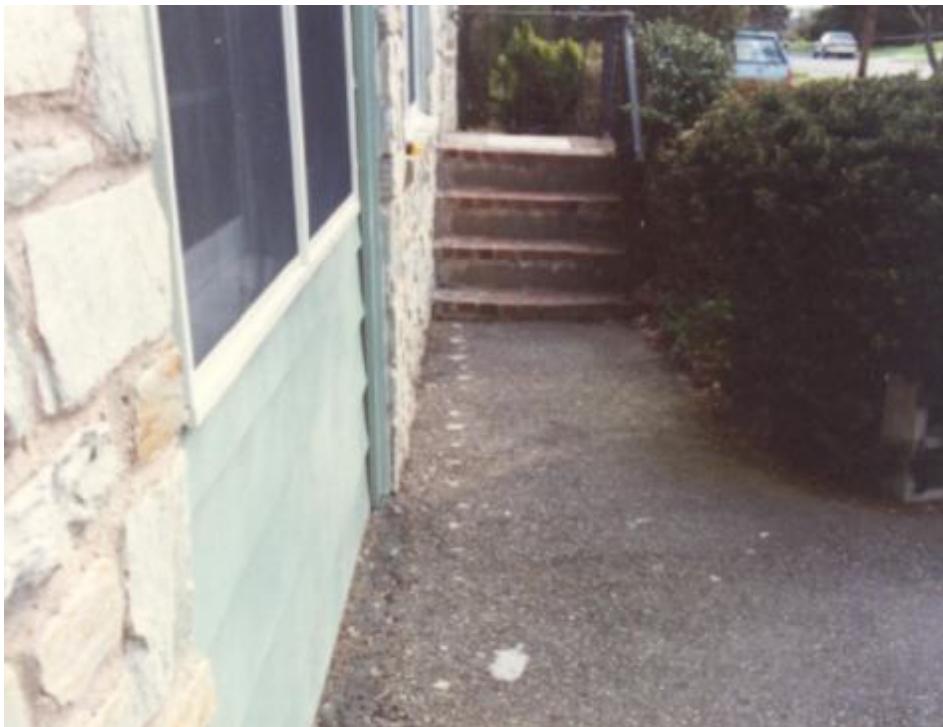
Figure 9-20

During this whole period of time, from the 1920's thorough today, a consistently used application technique included drilling through concrete near foundation walls to place the termiticide underneath. Over the years, industry practice on the spacing on these drill holes has shrunk from 24 inches, to 18 inches, to 12 inches. These drill holes are usually found within six inches of the foundation wall inside and out. The drilling of all interior perimeter concrete floors has never been a standard industry practice. Most companies are selective on what floors they drill and where specifically inside structures they will drill. Exterior drilling is more generally an overall industry practice. The drill hole sizes were usually 1/2 or 5/8 inches. Waterproofing companies have used the drill & inject technique too. Their holes are usually placed 24 to 36 inches apart and are 1 to 1 1/2 inches in size. The inspector should not confuse them.
